Manhole Inspection Summary

Manhole # S55A__013MH

Inspection ☐ Is Incomplete Rating: **3) Fair**

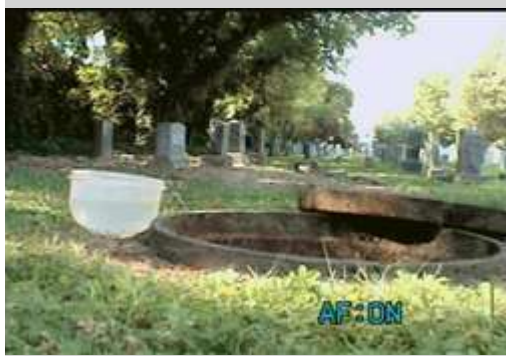
Location View

above grade 2 inches

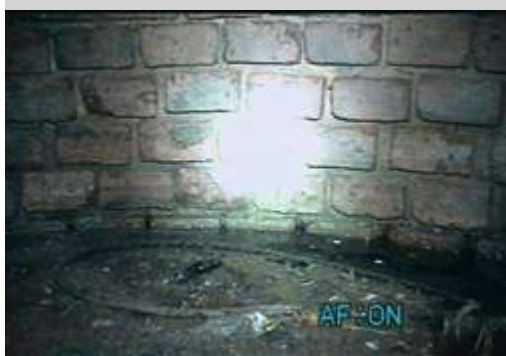
Defect 5

Condition: ☐ Sound ☐ Cracked ☐ Root Intrusion ☐ Deteriorated ☐ Leaks ☒ **Debris**

bench debris

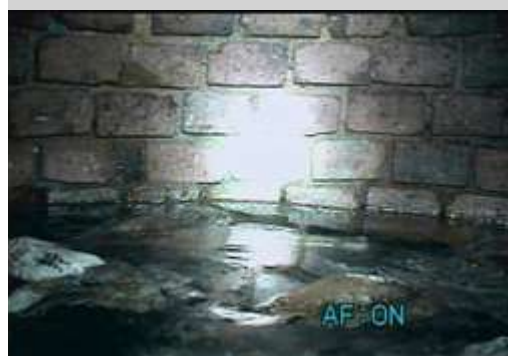
Defect 4

Condition: ☐ Sound ☐ Cracked ☐ Root Intrusion ☐ Deteriorated ☐ Leaks ☒ **Debris**

channel debris

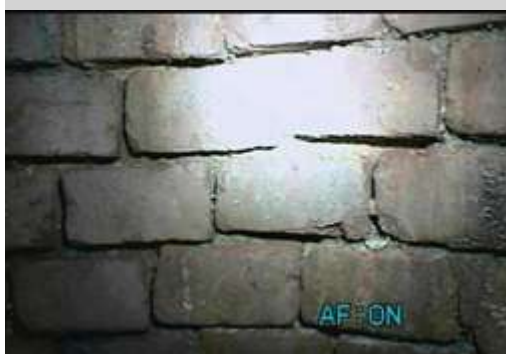
Defect 3

Infiltration: ☐ None ☐ Joint ☐ Cracks ☒ **Mortar** ☐ Roots ☐ Wall

missing mortar in barrel

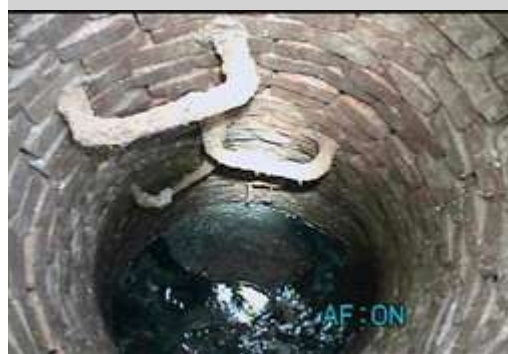
Defect 2

Count: **4** Missing: **1** ☒ **Corroded**

steps

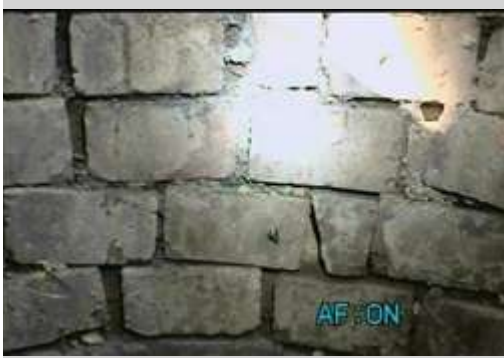
Defect 1

Condition: ☐ Sound ☐ Cracked ☐ Root Intrusion ☐ Loose Brick ☒ **Deteriorated**

Infiltration: ☐ None ☐ Joint ☐ Cracks ☒ **Mortar** ☐ Roots ☐ Wall

deteriorated, missing mortar in corbel

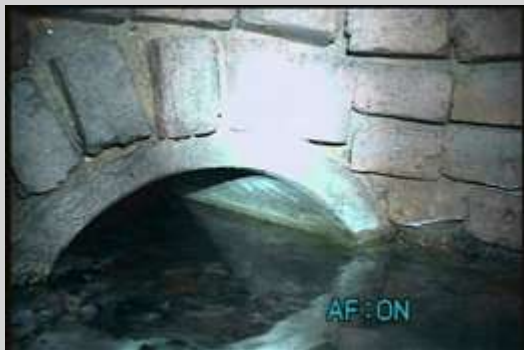
12 O'Clock Outflow

pipe turns under shelf couldnt see inside

Deposits: ☐ None ☐ Mud ☐ Sludge ☒ **Debris** ☐ Grease

Silt Depth: **4** (in.) Deposits Extent: **Heavy**

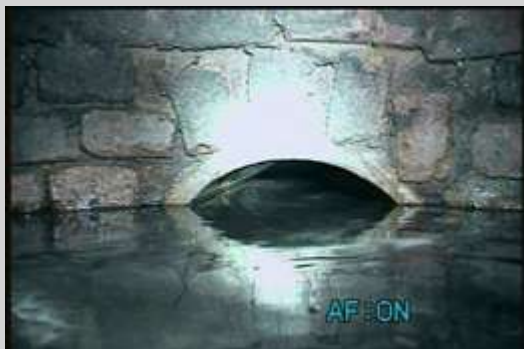
8 O'Clock Inflow

Deposits: ☐ None ☐ Mud ☐ Sludge ☒ **Debris** ☐ Grease

Silt Depth: **5** (in.) Deposits Extent: **Heavy**
